# EARTHQUAKE HAZARD CENTRE

## NEWSLETTER

APRIL 2007

<b>Editorial</b>	<b>p.1</b>
<b>Virtual site Visit</b>	<b>p.2</b>
<b>Sikkim Earthquake, India, Feb 2006</b>	<b>p.3</b>
<b>Non-Engineered Houses in Caracas</b>	<b>p.5</b>
<b>Prelim Report of Taiwan EQ, Dec 2006</b>	<b>p.7</b>
<b>1ECEES Announcement</b>	<b>p.8</b>

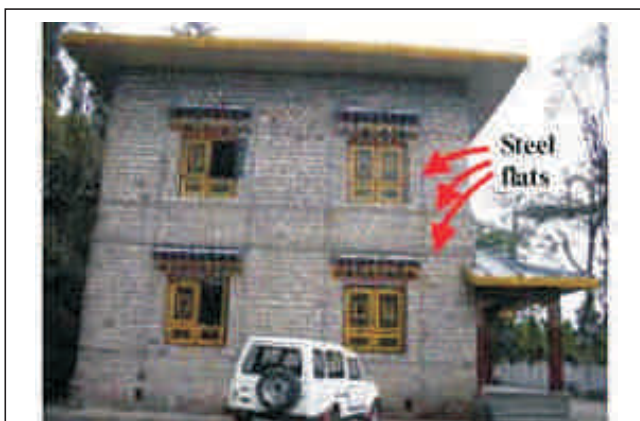
The two-storey Archive building was previously the Legislative Assembly building at Gangtok, until it was damaged during the 1988 Bihar–Nepal earthquake. Subsequently, this masonry building was retrofitted by fixing horizontal and vertical steel flats of about 50 mm x 8mm size on all the outer faces of the exterior walls in each storey (Figure 5). The building sustained no damage during the present earthquake. Clearly, sensible retrofitting of

Fig. 5. Good performance shown by retrofitted Archive building (arrows show steel flats used to retrofit the building after the 1988 Bihar–Nepal earthquake).

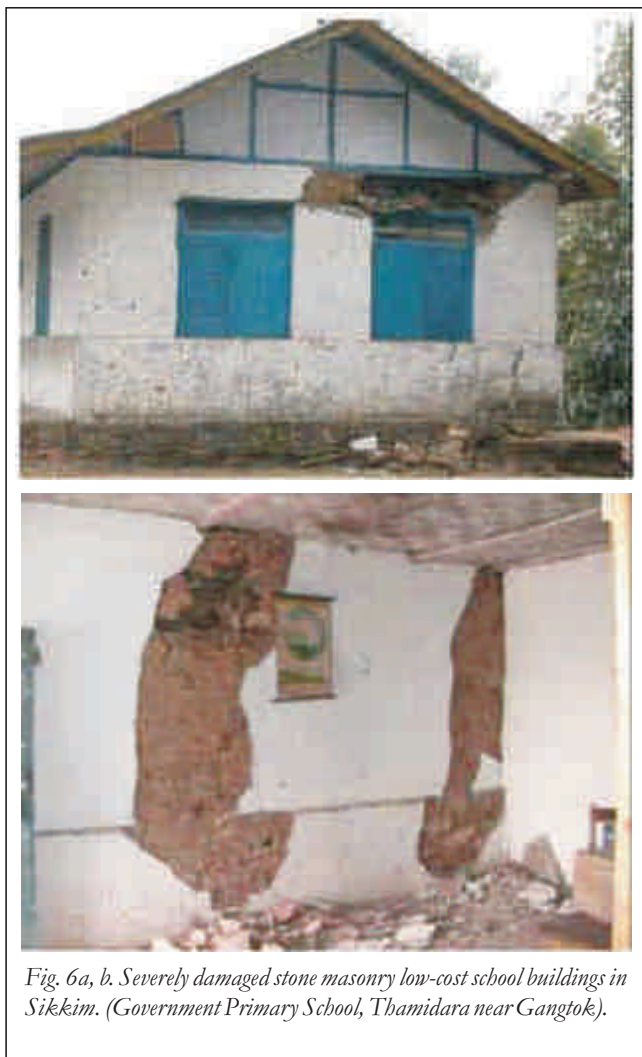
In rural areas of Sikkim, low-cost school buildings are generally constructed by the state government using stone masonry with mud mortar. Several such buildings suffered severe damage during the present earthquake. Earthquake resistant features such as horizontal bands at various levels and stones at the corners are generally not provided in such construction. This resulted in the formation of severe cracks near the corners and at the location of openings in such buildings, when subjected to even mild shaking (Figure 6). In addition, out-of-plane tilting of several masonry walls was observed at some places.

Fig. 6a, b. Severely damaged stone masonry low-cost school buildings in Sikkim. (Government Primary School, Thamidara near Gangtok).

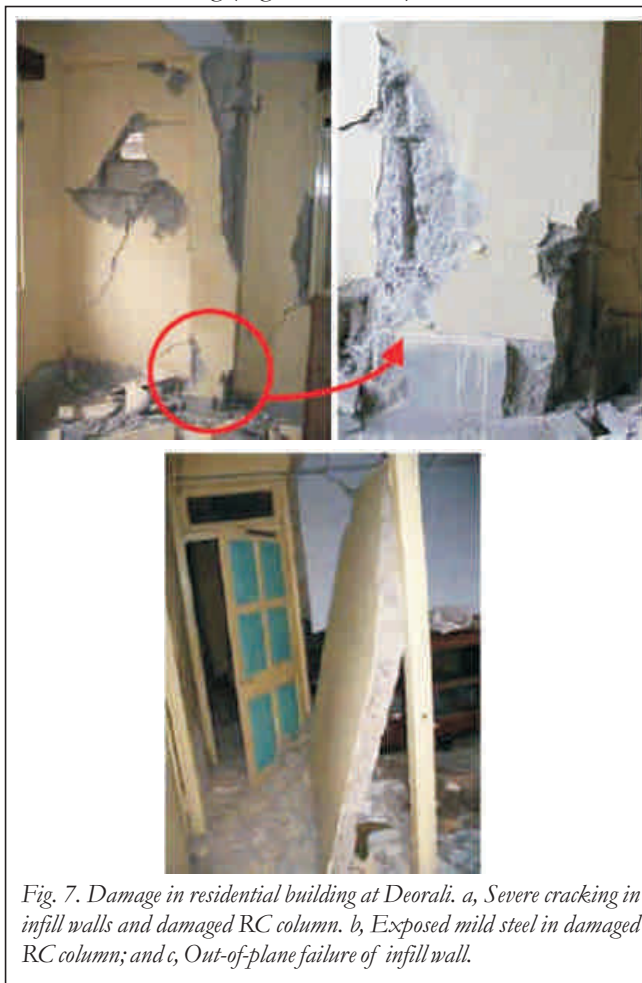
infill. Another four storey RC building at Deorali suffered damage and was evacuated. Severe damage was observed in several RC columns of the building, exposing mild steel bars as main reinforcement (Figure 7 a and b). Poor material quality and poor connection between perpendicular masonry walls resulted in out-of-plane failure of one infill wall, and severe damage to other infill walls in the building (Figure 7 a and c).

Fig. 7. Damage in residential building at Deorali. a, Severe cracking in infill walls and damaged RC column. b, Exposed mild steel in damaged RC column; and c, Out-of-plane failure of infill wall.

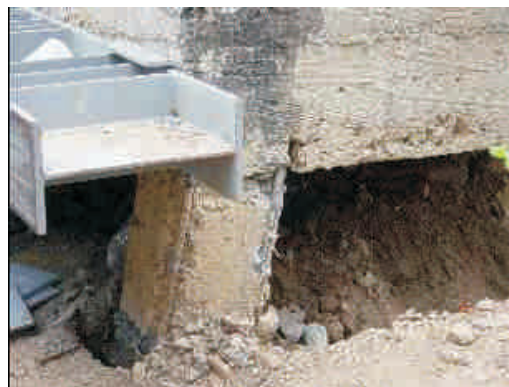
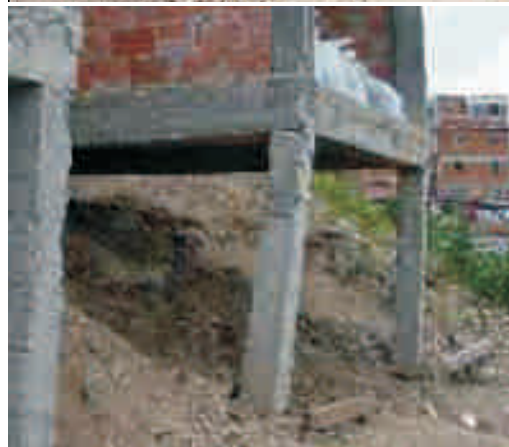
**Model 1** - The failure mode of the model 1 frame was column flexural collapse and plastic hinges were provided at the tops of columns.

Fig. 11. Flexural failure of short column (above) and flexural failure of long column (below) of Model 1.

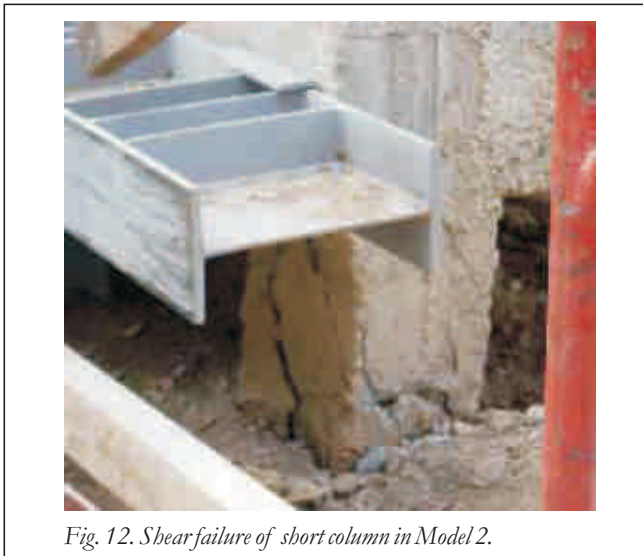
**Model 2** - The failure mode of short columns was flexural/shear mode at yield strength and shear failure occurred at the later stage. The failure mode of long columns was flexural failure, while shear diagonal cracks were also observed.

Fig. 12. Shear failure of short column in Model 2.

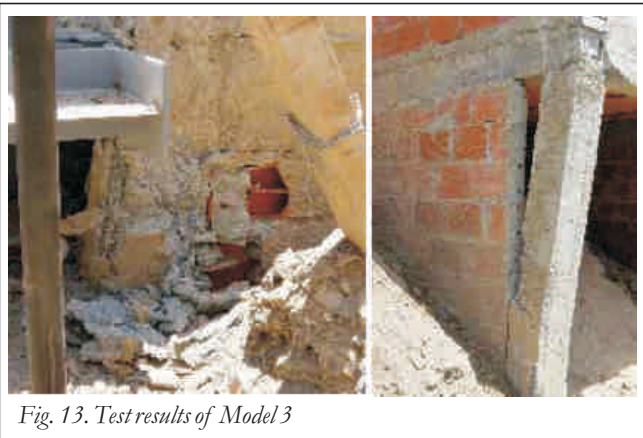
**Model 3** - Separation of clay hollow brick walls from columns and beams appeared from the beginning of loading and the combined effect with frames was not expected. It was found that clay brick walls did not significantly contribute to stiffness and strength compared to those of Model 2.

Fig. 13. Test results of Model 3

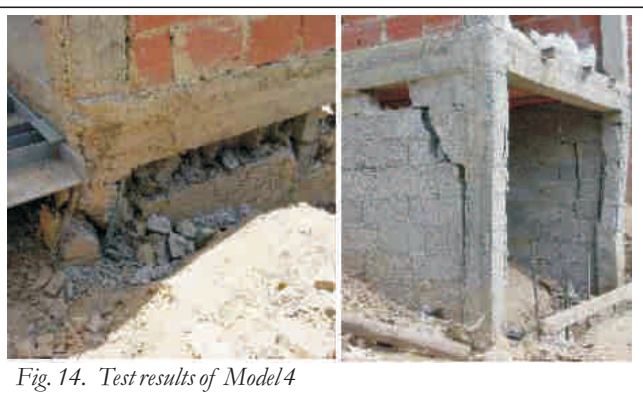
**Model 4** - Separation of hollow concrete block walls without re-bars from columns and beams started at an early stage of loading from 60 kN to 70 kN.

Fig. 14. Test results of Model 4

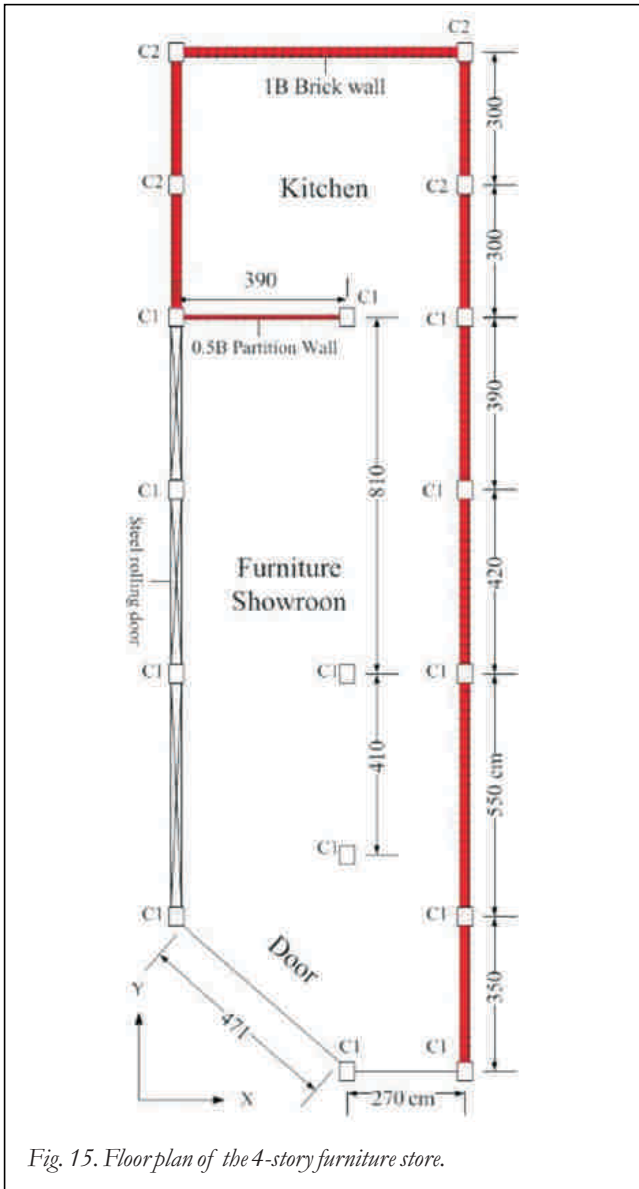
Fig. 15. Floor plan of the 4-story furniture store.

The four-story collapsed furniture store with residential upper floors was constructed in the early 1980s. The brick walls were first erected and then reinforced concrete columns, beam, and slab were constructed using the brick wall as part of the formwork (reinforced masonry building). The total width and length of this building is 7 m x 23 m, respectively. The first floor of this building was for commercial use, and the rest of the floors were residential. Large openings for doors and windows were located at the street sides of the building. The frames above the ground floor were infilled with a brick masonry perimeter and partition walls. Thus, the bottom floor was comparatively weak due to the open front and open space. Figure 15 shows the schematic plan views of the building. There

were a total of 15 columns. Along the long axis, the number of spans ranged from four to six; along the short axis there were one to two spans. There was obviously not enough redundancy. Most of the brick walls were located on the right side along the long axis, which made the planar lateral stiffness asymmetric. Figure 16 shows the collapsed building after the main aftershock. A few other street-front residential buildings were also damaged. Brick walls and beams were seriously stressed, and the interior ground was cracked.

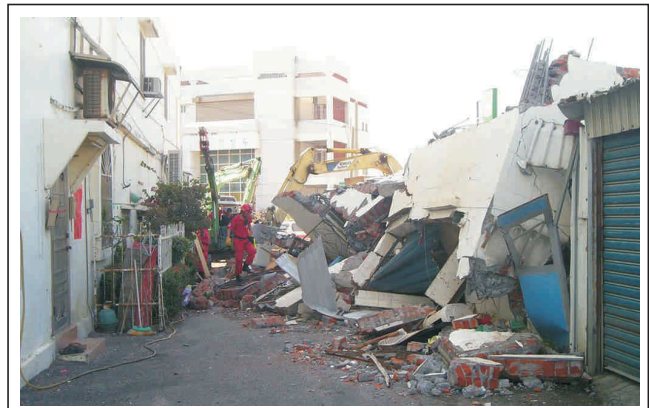
Fig. 16. Side view of the collapsed furniture store.
