# EARTHQUAKE HAZARD CENTRE NEWSLETTER

Vol.17 No.1

JULY 2013

| <b>Building Pounding Damage Observed in the 2011 Christchurch Earthquake</b> | <b>p.5</b> |

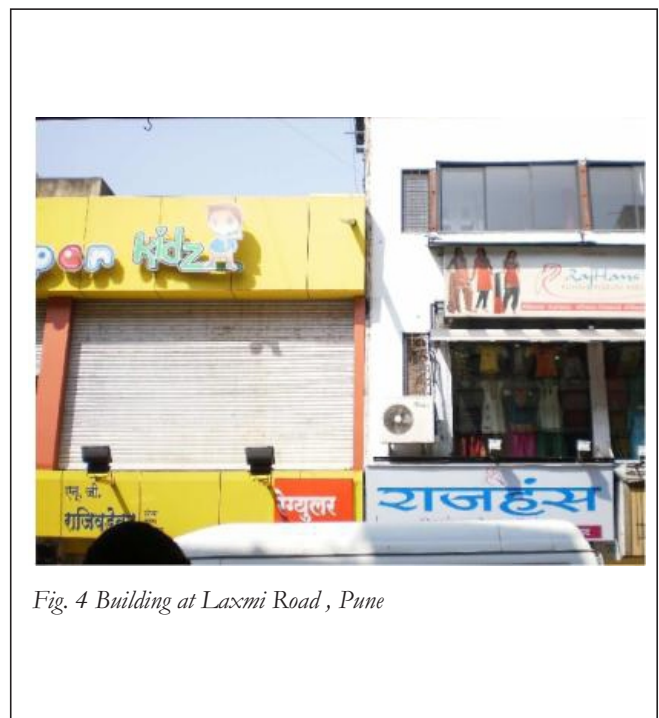
Fig. 4 Building at Laxmi Road , Pune

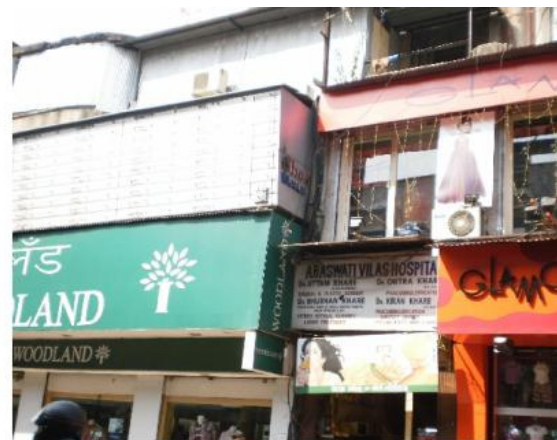
Fig. 7 Building with façade setback, Pune.

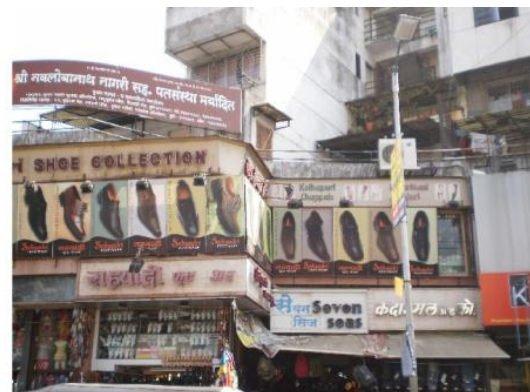
Fig. 8 Adjacent building with different heights, Pune.

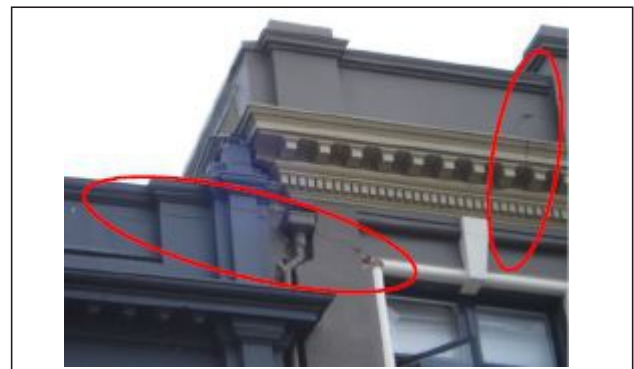
Pounding damage to URM buildings (for example, Figures 9 and 10) occurred sufficiently frequently to enable identification of common damage patterns (Figure 11). Masonry cracking typically extended from the topmost point of contact between two buildings to the nearest window arch or lintel in each building. Cracking frequently extended further from the window opening through to the

Fig. 9 Examples of URM pounding damage: minor damage.

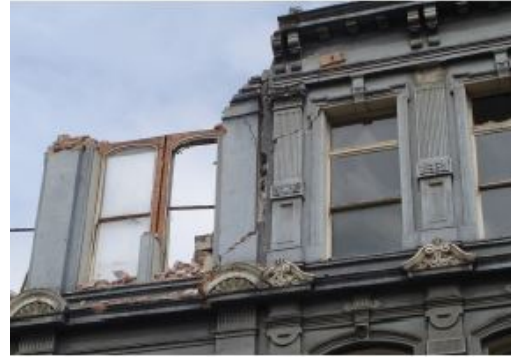
Fig. 10 URM: Major damage partially caused by pounding.

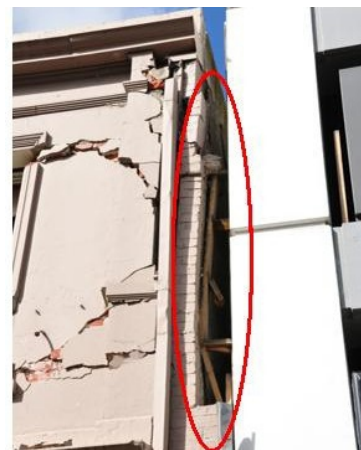
The primary source of pounding damage in modern buildings with separation was instead observed where building separations were infilled with cosmetic flashings (Figure 13). While flashings are intended to cover the gap between adjacent buildings, the detailing of some flashings created stiff and strong elements, which transferred significant force between the two buildings. In some instances the flashings caused failure of adjacent building elements, while in other instances the entire flashing detached from both buildings. Flashing detachment can cause a sizable amount of falling debris when the buildings have multiple storeys. Furthermore, this form of damage can be simply avoided by designing flashings to compress/crush and ensuring they are adequately anchored to one building only. Five instances of significant damage resulting from force transfer through building flashings were observed within the CBD.

Fig. 13 Building damage caused by framed flashing.

2. Modern buildings were primarily endangered by pounding when flashings between buildings were constructed with stiff and strong materials that allowed force transfer across building separations. This hazard can be mitigated by using compressible flashings attached to one building (but not both).

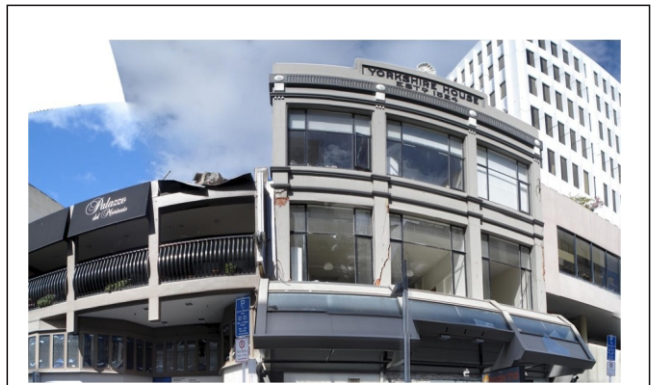
greatly differing overall heights. This is again primarily attributed to the greater separations that generally surround taller buildings. However, Figure 14 presents one building configuration where extensive pounding damage did occur. Pounding between the central building and the taller rightmost building also occurred in the Darfield earthquake. The damage in the Darfield

earthquake was minor, although it was noted that this damage occurred in the vertical elements of the primary gravity structure.

The Christchurch earthquake significantly increased the damage in the central building, and also caused damage at the boundary with the leftmost building. At the right interface of the central building the observed damage is predominantly spalling, although cracking also extended below the contact interface. The damage at the left interface is more severe. The masonry column of the central building has been offset approximately 30 mm due to collision with the left building. It is considered that the central building was crushed by the surrounding buildings, primarily due to the greatly differing earthquake response of the taller rightmost building. The range of buildings affected by pounding sometimes extended to buildings where pounding would not normally be anticipated. One single storey building was observed to suffer substantial pounding damage as a result of contact with a neighbouring four storey building.

*Fig. 14 Pounding damage caused by buildings with greatly differing heights. Note image is distorted due to panoramic photography.*

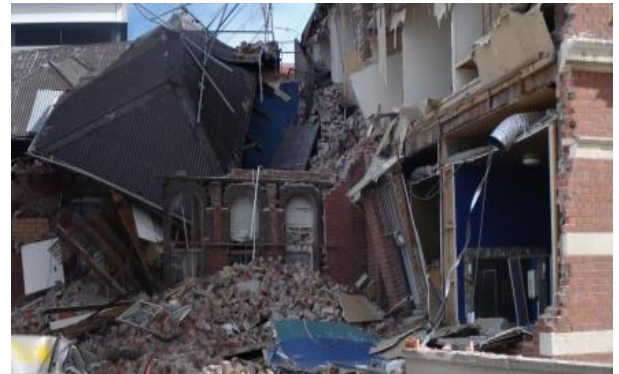
Two building collapses within the CBD are partially attributed to pounding. Both these cases involve URM buildings that were constructed circa 1900. Figure 15 illustrates the damage caused to a two storey URM building that sustained pounding during the Christchurch earthquake (shown on the left). Significant damage has also been sustained by the adjacent right building. These buildings were externally surveyed after the Darfield earthquake and were found to be separated by approximately 50 mm at ground level, but were in contact at roof level.

It was concluded that the two storey building had begun to lean, although whether this was due to the Darfield earthquake could not be determined. As these buildings were in contact, pounding undoubtedly occurred during the Christchurch earthquake. However, the primary cause of collapse is attributed to the URM construction. Whether pounding appreciably contributed to this collapse is very difficult to determine, due to the level of destruction that has occurred.

*Fig. 15 Two storey building collapse involving pounding. Primary cause of collapse is attributed to URM construction.*

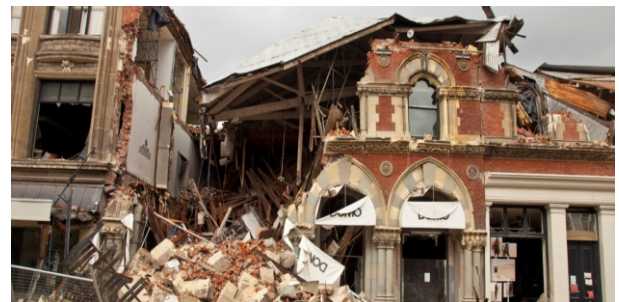
The damage shown in Figure 16 indicates that the central and leftmost buildings were likely to be constructed with a shared party wall. This can be observed where wall sections remain standing at the building interface. At the second level, a 100 mm thick brick wall appears to have supported both buildings. This evidence is also supported by the interior finishings that can be observed on the

*Fig. 16 Building collapse involving building pounding. Primary cause of collapse is attributed to URM construction. Photo courtesy of Colin Monteath, Hedgehog House.*

'exterior' of this wall. Nevertheless, localised damage consistent with pounding is present between the central and rightmost buildings. Once again it is difficult to discern the level of influence pounding has had on the presented collapse. The primary cause of collapse is attributed to the URM construction. However, it is credible that the severity of this damage would have been greatly reduced if adjacent buildings had not been present.
